Report No. B4027.TR04.07  
January 2008

## **MERSEY GATEWAY**

### **MORPHOLOGICAL MONITORING - FINAL REPORT**

**Halton Borough Council**  
Rutland House  
Halton Lea  
Runcorn  
WA7 2GW

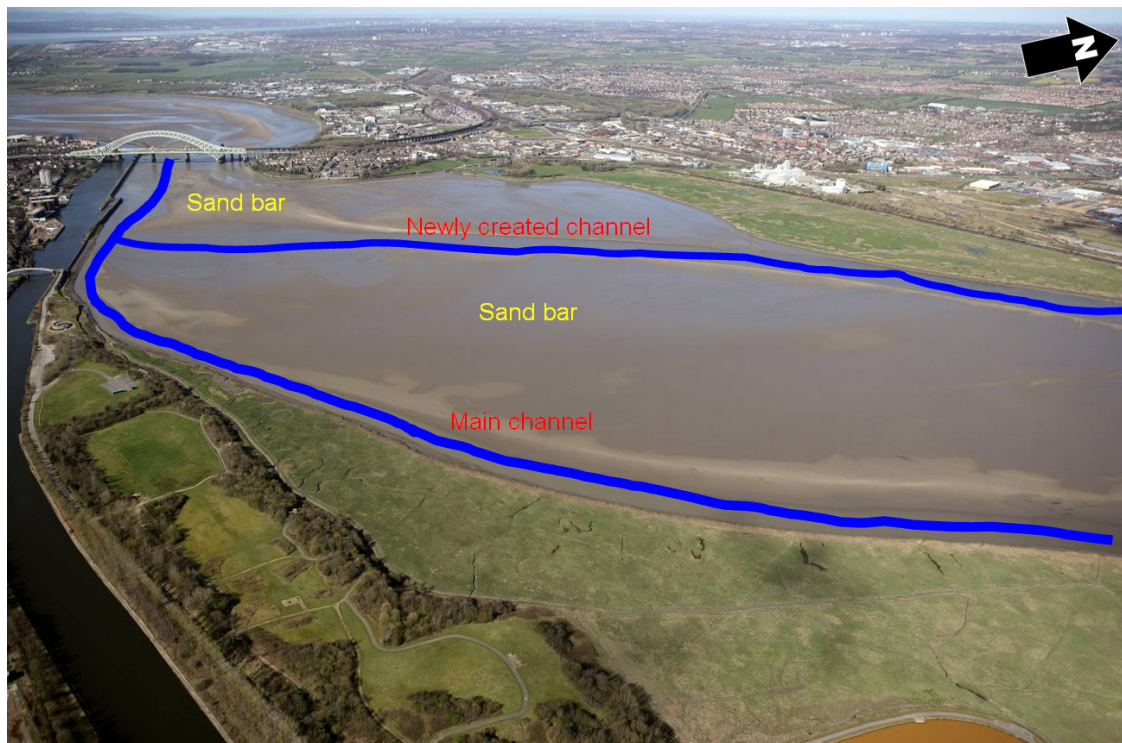
**Figure 3.7 Oblique aerial photo taken on 17 March 2007 during the topographic Survey**

- 3.3.5 Additional daily flights were undertaken during the topographic surveys. The full schedule is given in Report No B4027.TR04.07. Figure 3.7 is an example of an oblique aerial photograph

taken during the last topographic survey. The picture shows the channel behaviour and both the mobility and sinuosity of the channel (blue colour).

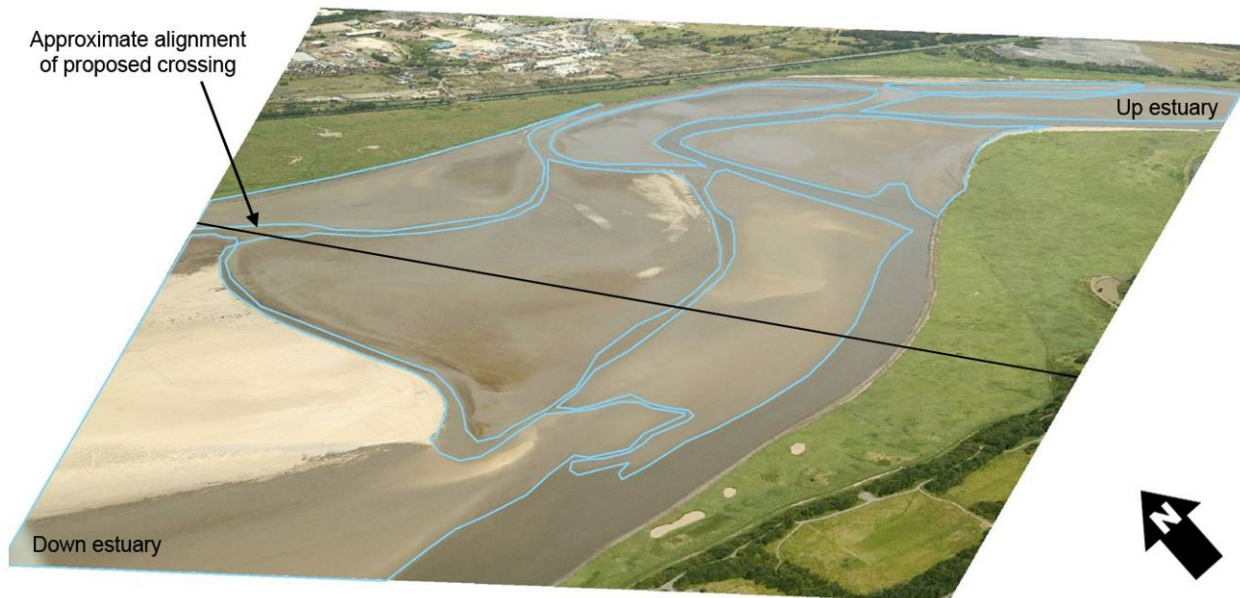
**Figure 3.10 View 3 – S2 Wigg Island (upstream view), Hempstones Point visible on the right**

- View 3 (Figure 3.10), also of S2, looks northwest with Wigg Island visible on the right. The proposed Mersey Gateway would cross this view;
  - View 4 (Figure 3.11) of S3 is from the southern edge of the estuary and shows the area immediately upstream of the Silver Jubilee Bridge; and

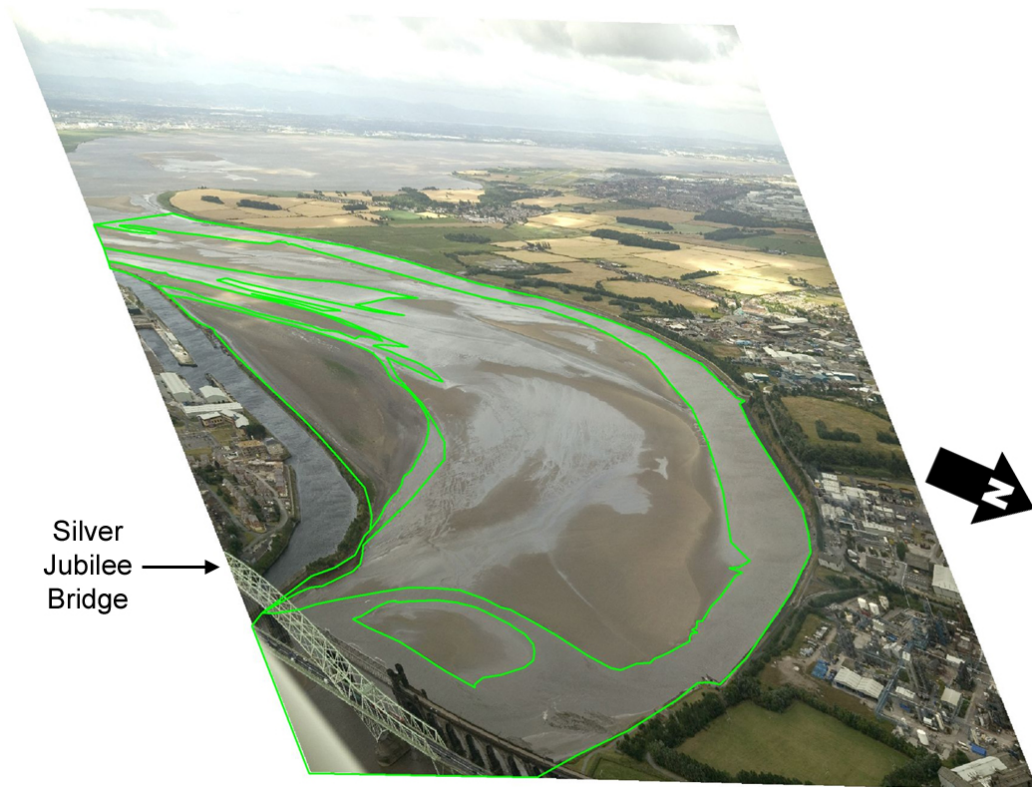
**Figure 3.12 View 5 – S4 Silver Jubilee Bridge (the area down-estuary from the Silver Jubilee Bridge)**

- View 5 (Figure 3.12) of S4 covers the area down-estuary of the Silver Jubilee Bridge.

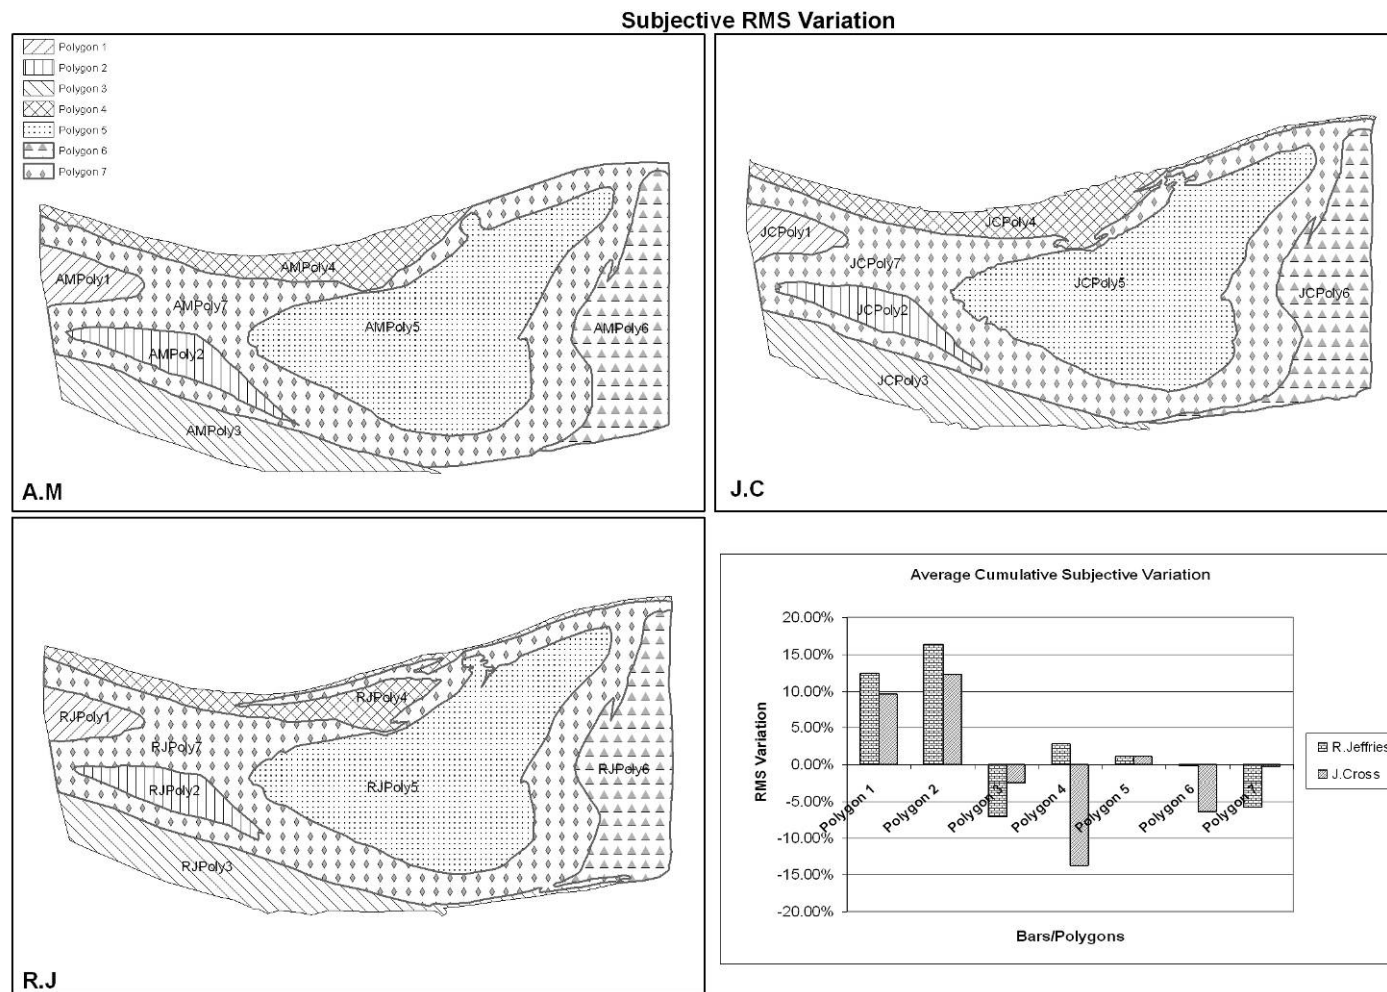
**Figure 3.13 Example of the Oblique Aerial Photos Limitations - Digitising Error**

- 3.3.23 Slight differences in the height of the tide at low water could still alter the visual interpretation of morphological features. Because the image processing method does not allow direct measurements, this error cannot be quantitatively investigated. However, in order to make a qualitative assessment, the tide height (as recorded at Old Quay Lock) was included in the table of changes (Appendix 2). This demonstrates that tide height shows very little difference between photographs in the observed area of the inundated Estuary.

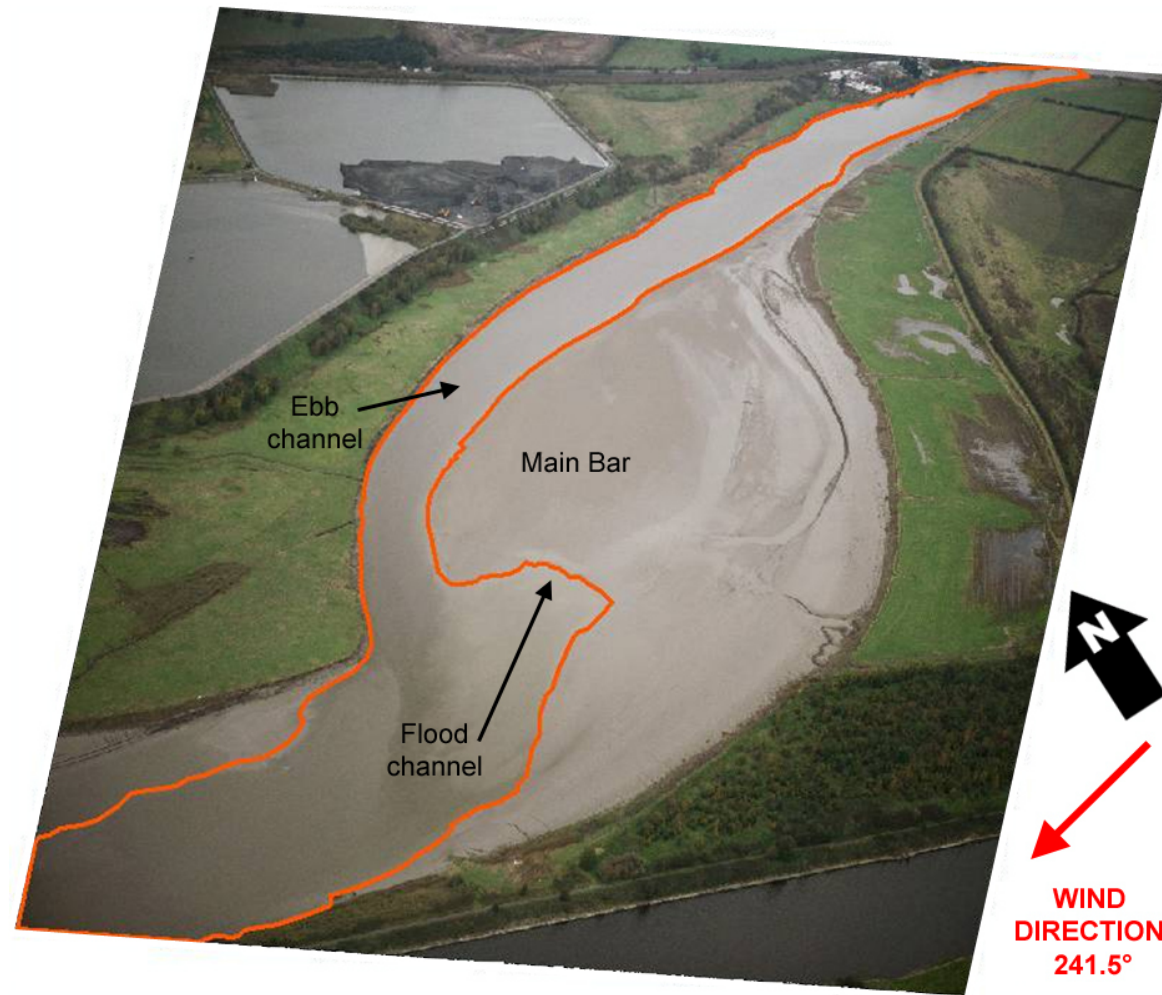
**Figure 3.19 The location of the low water channels at S1 Norton Marsh – 06/11/2006**

Image taken: 10:47 BST    LW at time of image: 3.13m    LW recorded at Old Quay Lock: 10:00    LW Height 1.23m

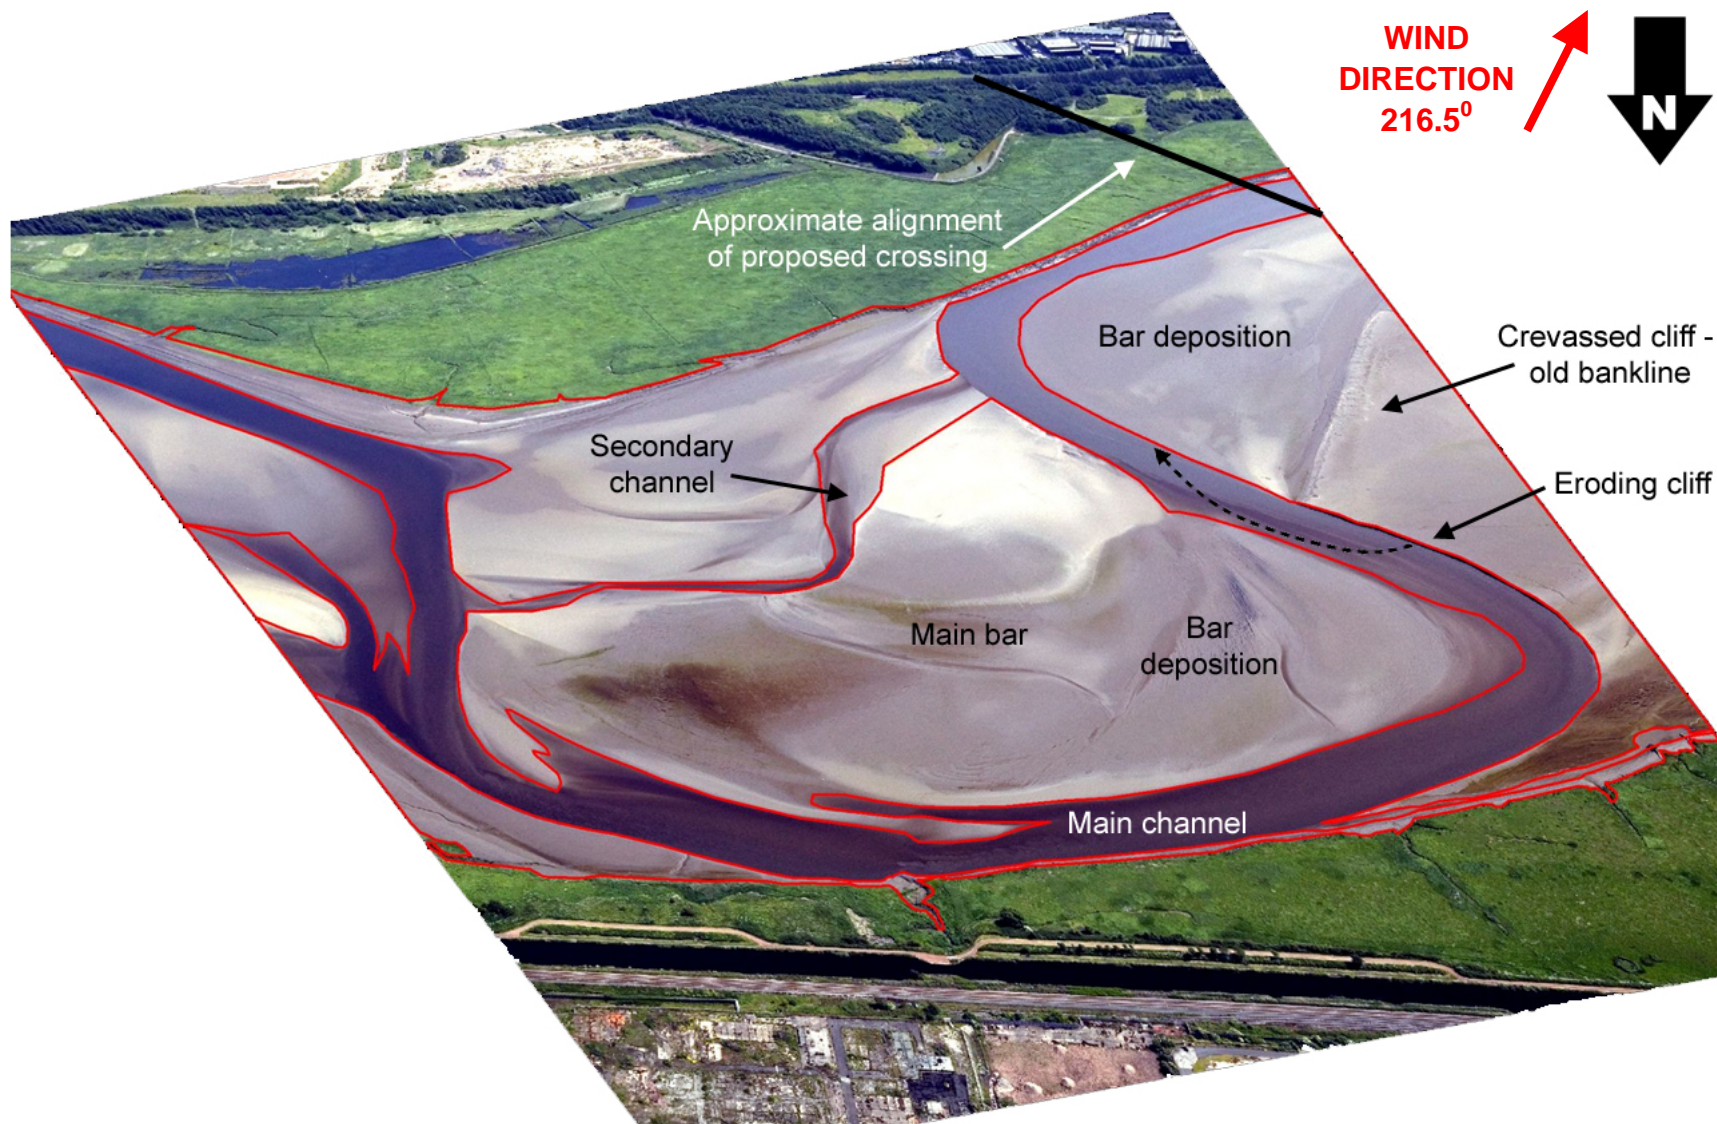
**Figure 3.23 The location of the low water channels at S2 Wigg Island (downstream view) - 15/06/2005**

However, significant morphological change was noted between 15/06/2005 and 22/06/2005 with only the influence of a neap tide between these dates.

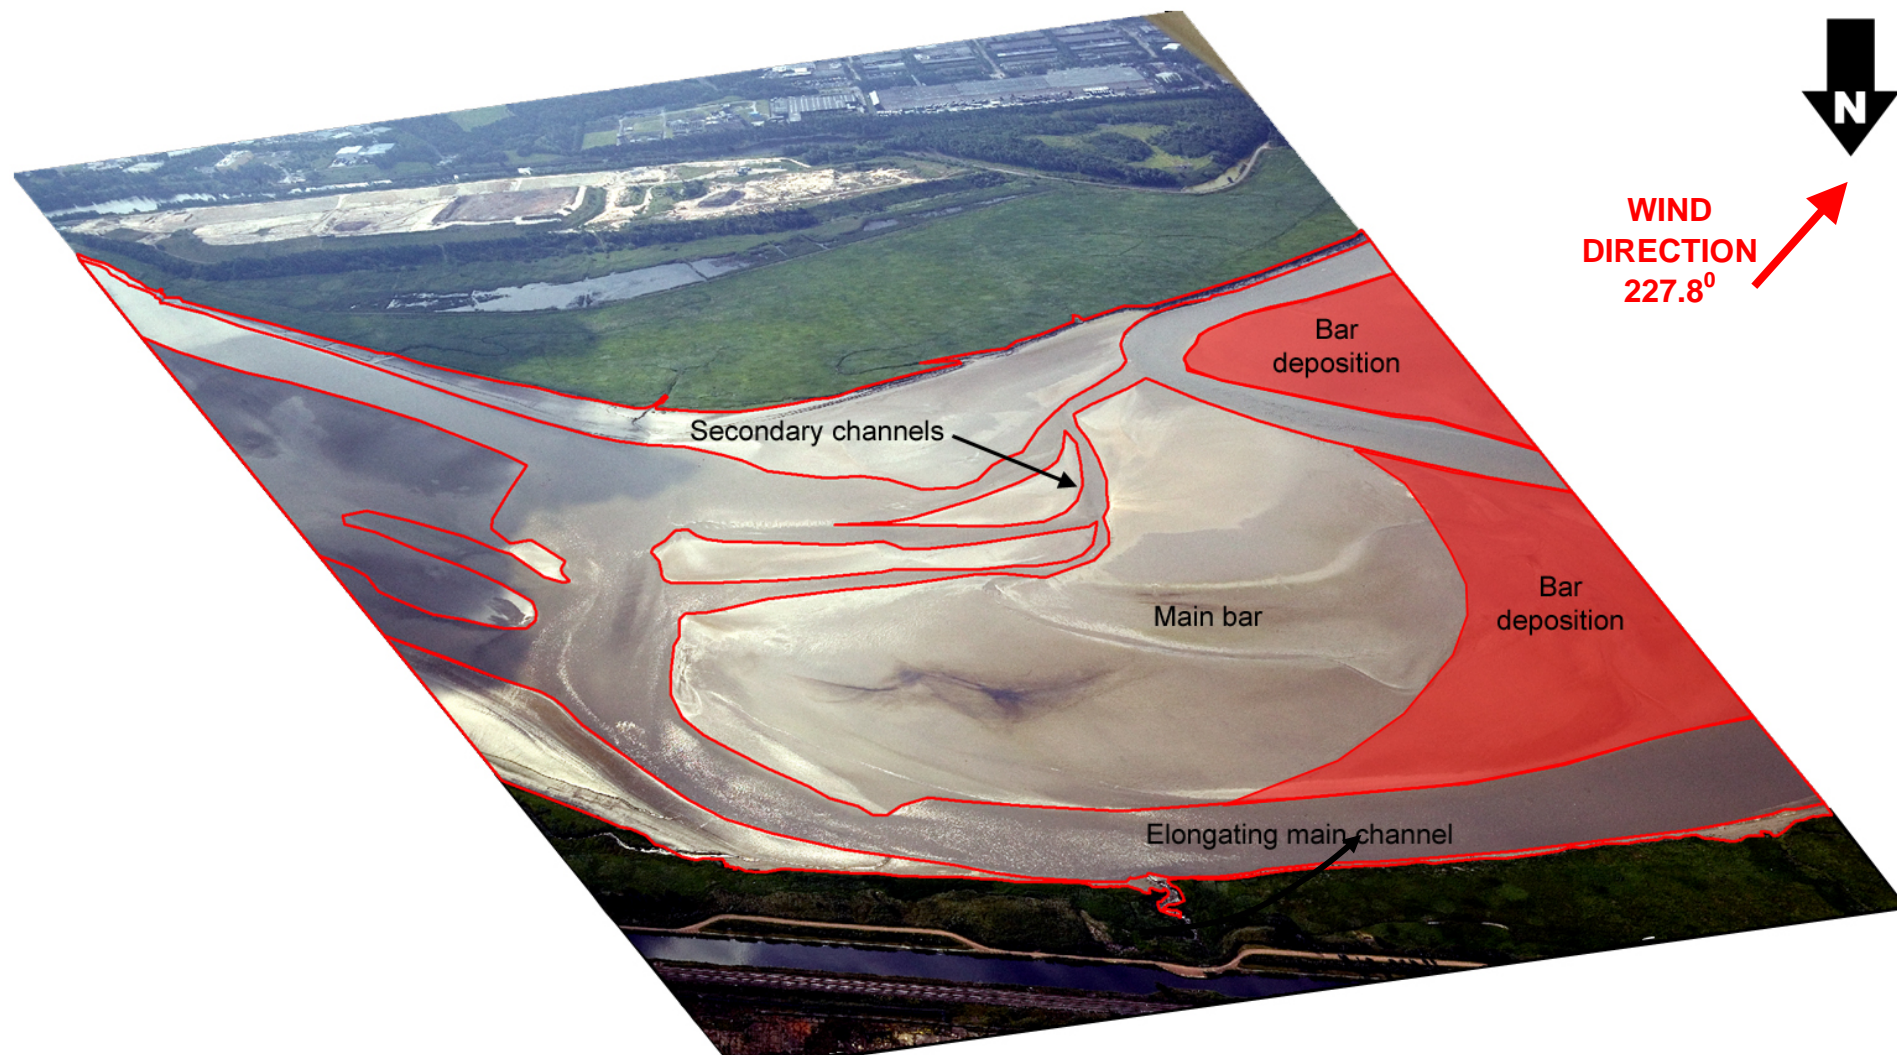
**Figure 3.24 The location of the low water channels at S2 Wigg Island (downstream view) - 22/06/2005**

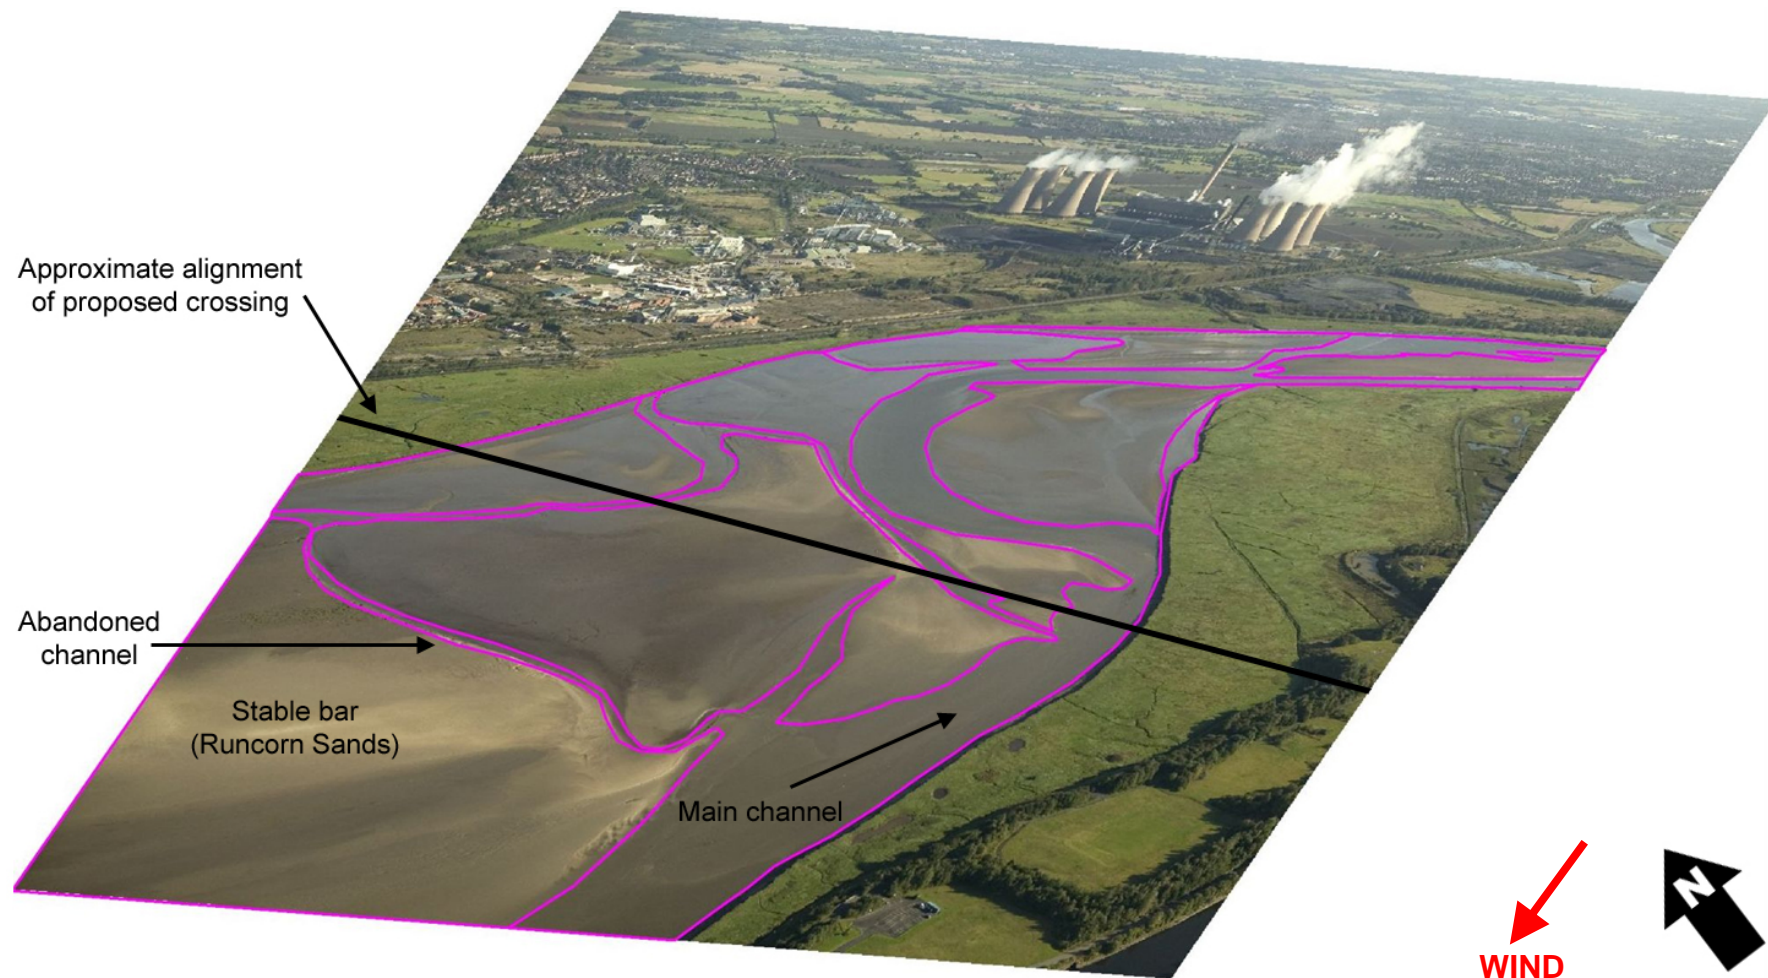
**Figure 3.31 Low flow channels and ebb delta, Wigg Island (upstream view) – 16/09/2005**

- 3.4.11 Visual analysis of the oblique aerial photographs is based on figures 3.28 to 3.35 which are displayed in subsequent pages.
- 3.4.12 The channel lengthening and observed switching described above is also visible in Figures 3.28 (12/05/2005), 3.29 (08/06/2005) and 3.30 (13/07/2005). These figures also show clearly that the flood intrusion cutting across the bar to the south of the Estuary is an extension of the low flow channel that runs along the base of the images. This highlights that the broad shape of the Estuary – rather than the detail of the low flow channel – controls the direction of the flood tide, which apparently sweeps up the Estuary and across the bar.

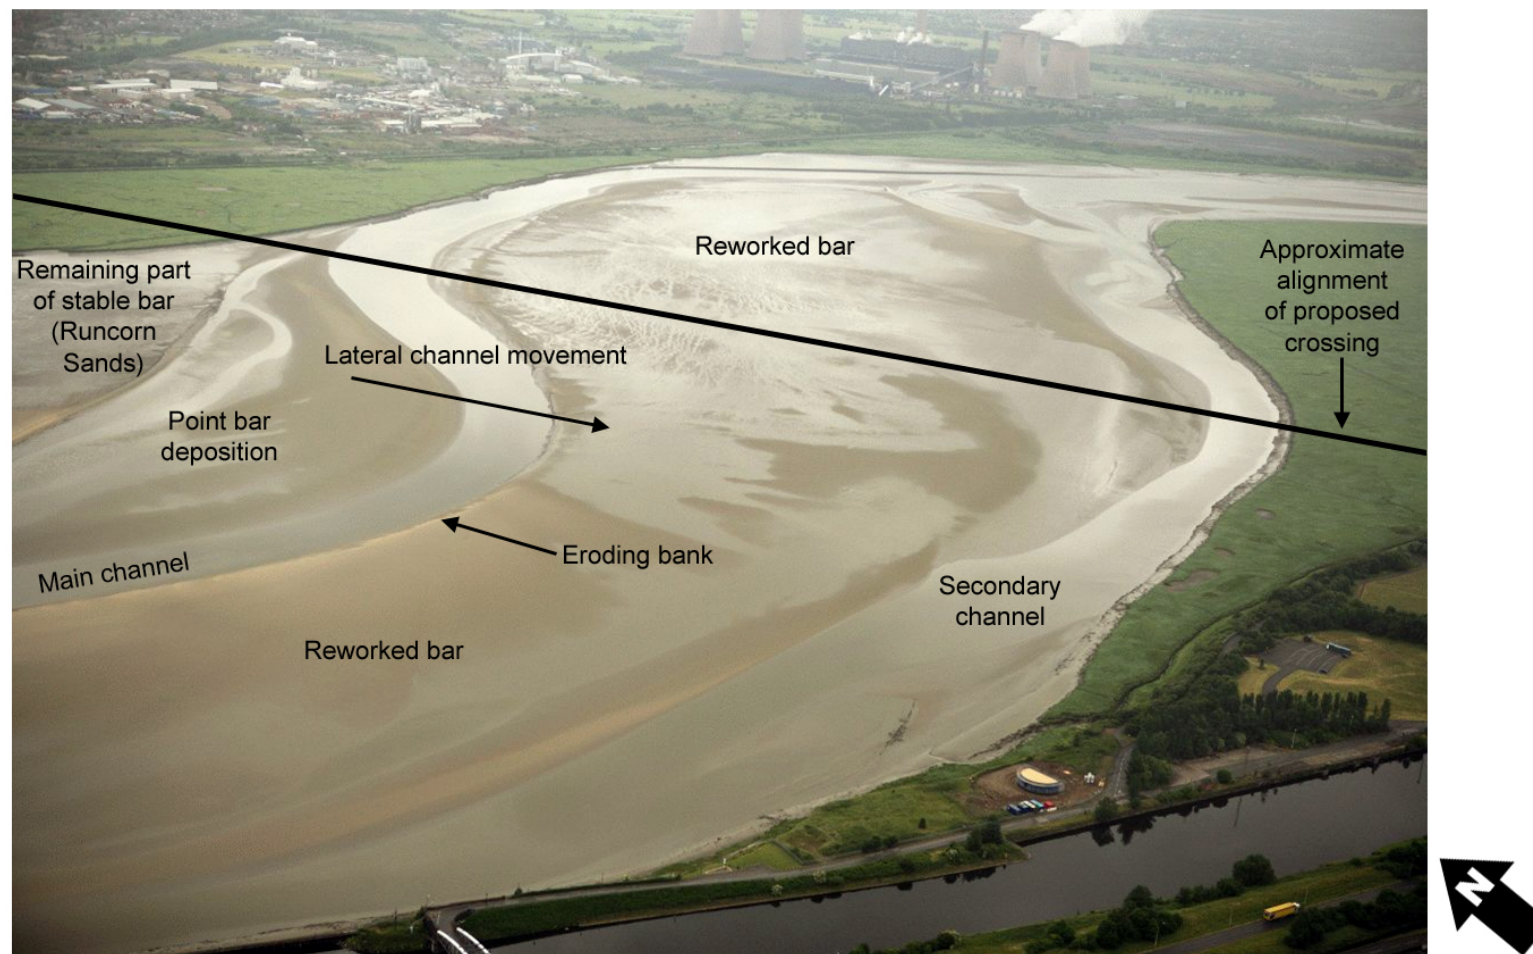
**Figure 3.35 Downstream migration of main channel, Wigg Island (upstream view) – 19/06/2006. Unrectified / untraced image.**

Image taken: 16:29 BST    LW at time of image: -    LW recorded at Old Quay Lock: -    LW Height -

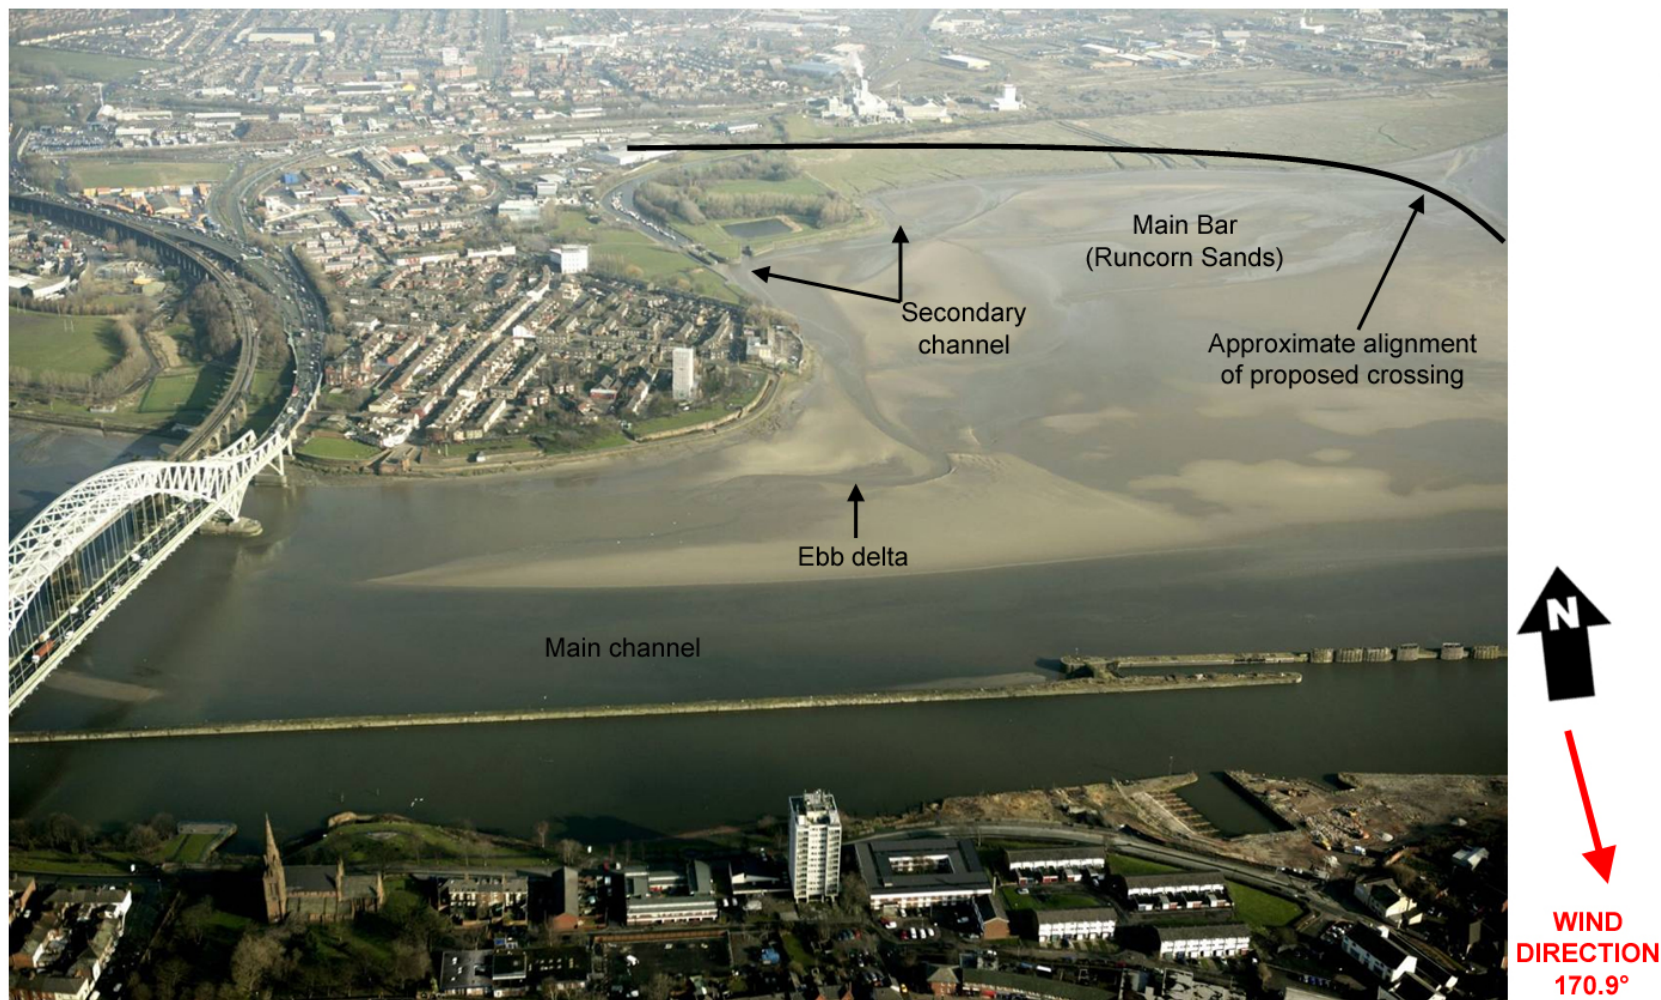
**Figure 3.40** Untraced / unrectified image showing change in ebb delta location. S3 upstream of Silver Jubilee Bridge from V4 on 14/03/2006

Image taken: 09:24 BST    LW at time of image: 1.16m    LW recorded at Old Quay Lock: 09:00    LW Height 1.16m

- 3.4.20 Figure 3.36 (29/04/2005) shows a large stable bar occupying the centre of the estuary. To the west a secondary channel runs up to the lock and along the northern bank. Figures 3.36 to 3.44 show that the same area over the next 5 months varies only slightly. A distinct tide line is visible on the main bar in Figure 3.37 (20/07/2005), showing that this bar does not always become inundated. Flood levees are visible on Figure 3.38 (21/09/2005). An ebb flow delta is clearly visible in Figure 3.39 (25/11/2005), and this delta moves downstream (Figure 3.40; 14/03/2006).

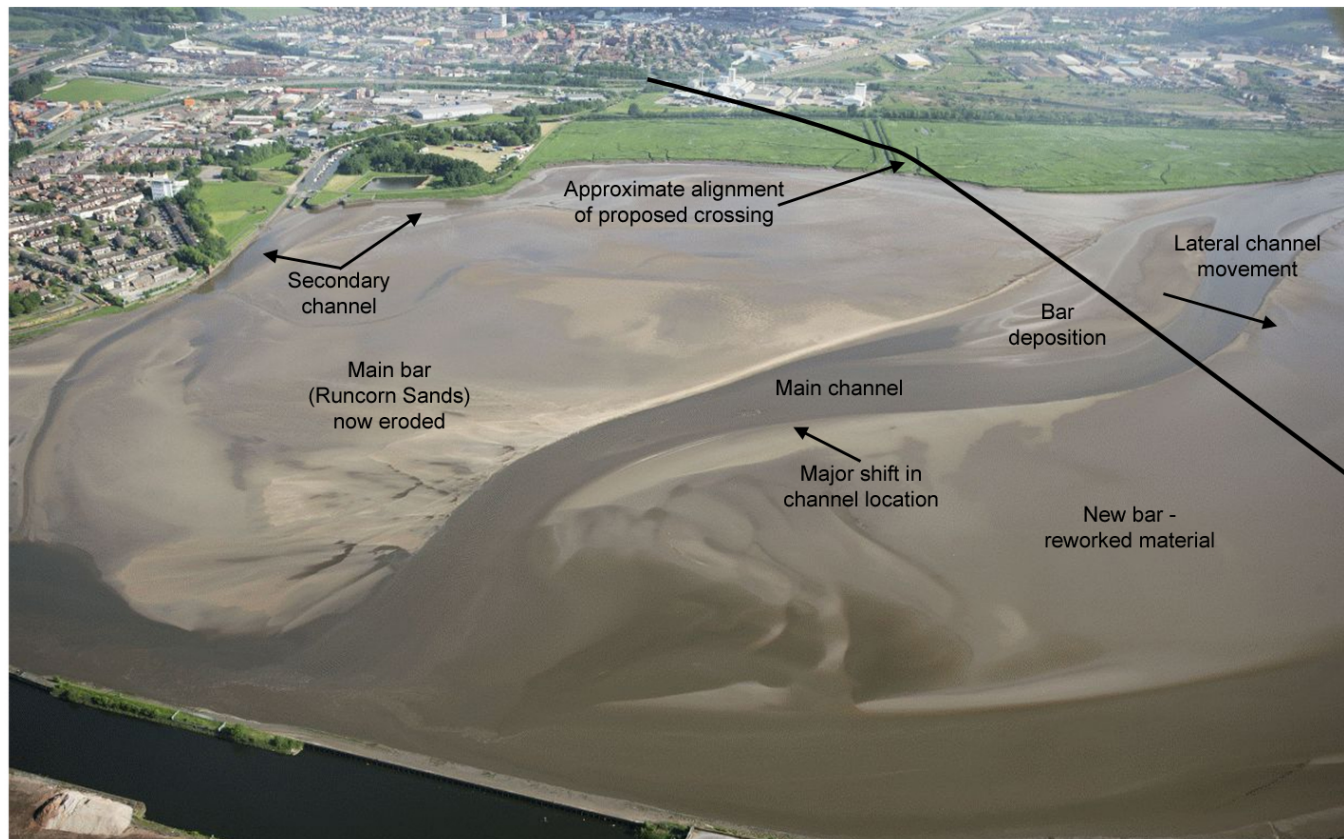
**Figure 3.42 Unrectified and undigitized image from S3 upstream of Silver Jubilee Bridge from S4 on 25/05/2006**

Image taken: 08:43 BST. LW at time of image: - LW recorded at Old Quay Lock: - LW Height -  
 “-“ data were not available

- 3.4.21 However, Figures 3.41 to 3.43, taken between 14/04/2006 to 19/06/2006, show a major change in position of the main channel towards the west. This underlines that the dynamic channel belt can appear to be stable over several months, and then switch in a short period of time to a previously dormant zone.

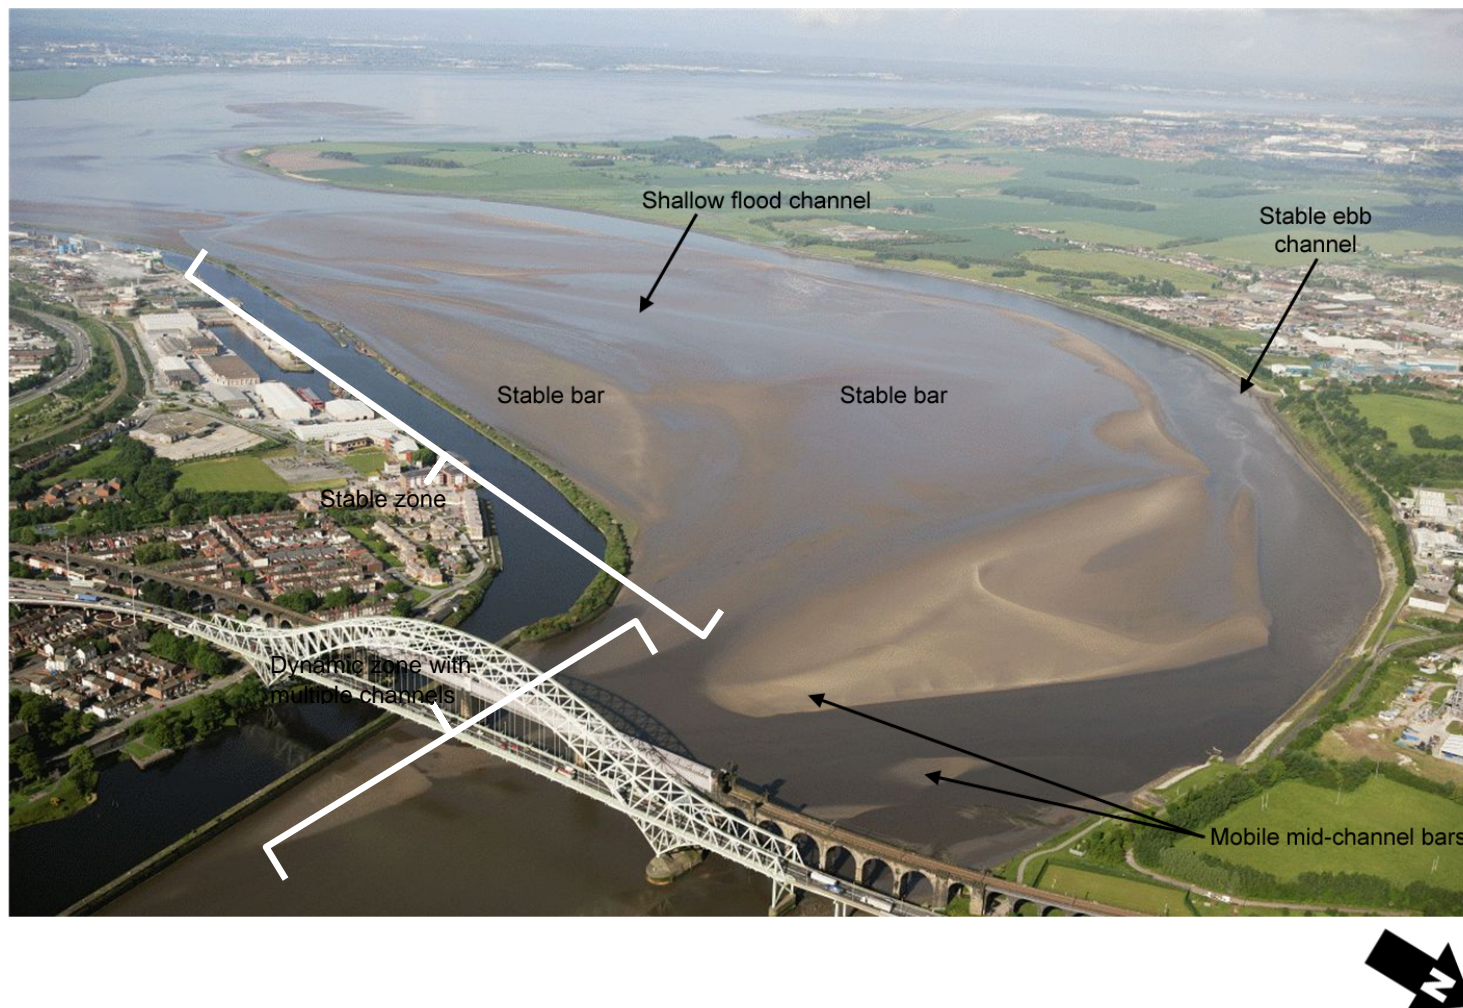
**Figure 3.49 Channel locations at S4 Downstream of Runcorn Gap 25/05/2006 (unrectified / undigitized image)**

Image taken: 10:47 BST    LW at time of image: 3.13m    LW recorded at Old Quay Lock: 10:00    LW Height 1.23m

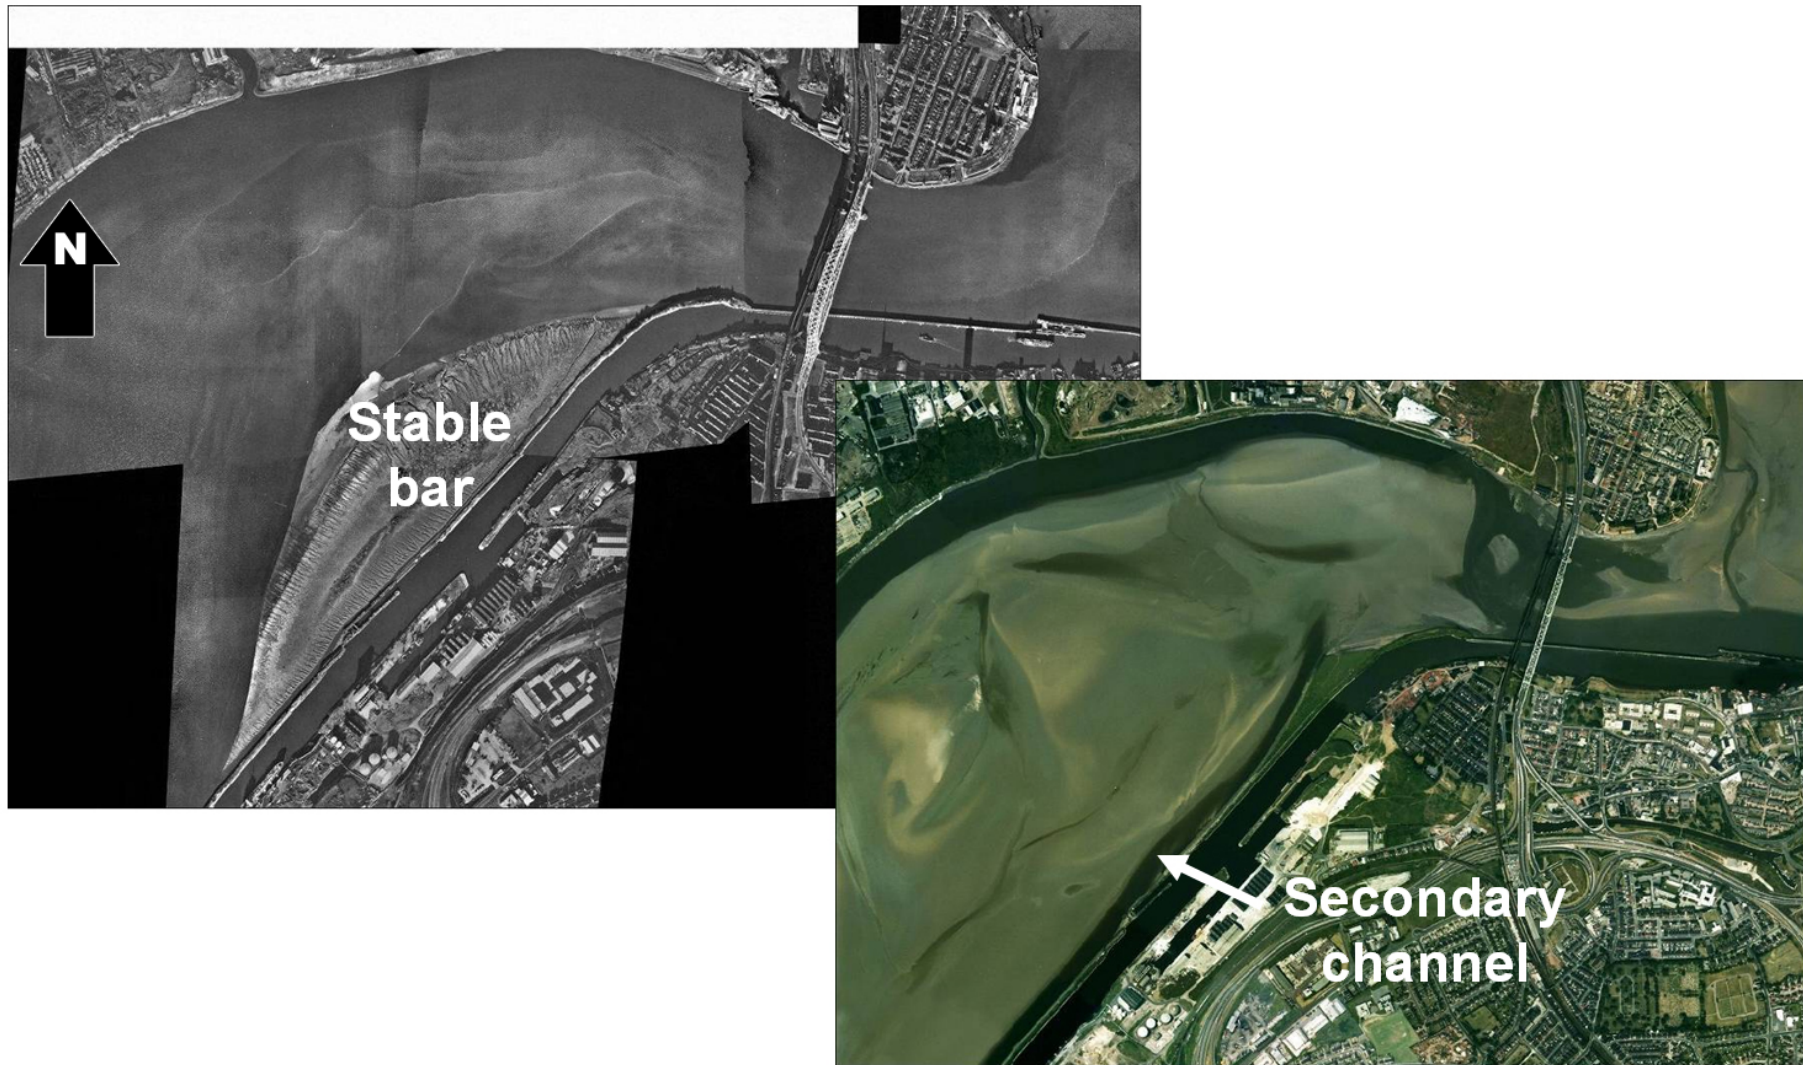
**Figure 4.5** Air photos of S4 in 1975 and 1991, showing the loss of a bar and creation of channel

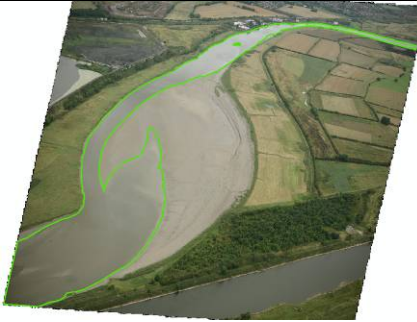
21/08/2006

6.94	298.1		Dominant channel located towards then north bank and meanders across the estuary to the south bank. Lobate flood intrusion channel cuts into main bar	No active secondary low flow channel visible			None	None			31.73
19/09/2006

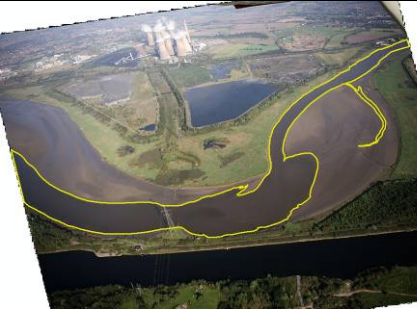
7.24	257.5		Dominant channel located towards then north bank and meanders across the estuary to the south bank. Lobate flood intrusion channel cuts into main bar	No active secondary low flow channel visible			None	None			22.79
20/10/2006

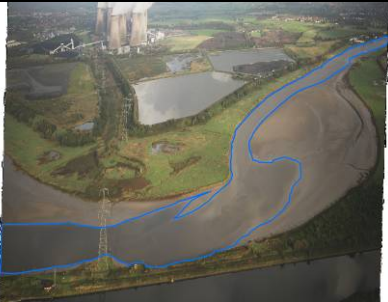
1.69	193		Dominant channel located towards then north bank and meanders across the estuary to the south bank. Lobate flood intrusion channel cuts into main bar	No active secondary low flow channel visible			None	None			28.96

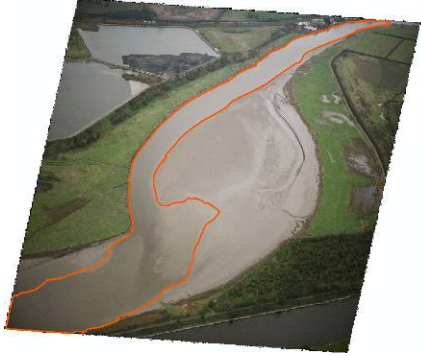
2.28	241.5		Dominant channel located towards then north bank and meanders across the estuary to the south bank. Lobate flood intrusion channel cuts into main bar	No active secondary low flow channel visible			None	None			20.86

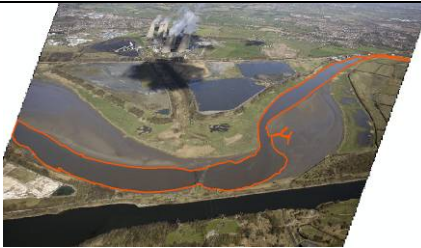
1.87	310.2	0.5	Dominant channel located towards then north bank and meanders across the estuary to the south bank. Lobate flood intrusion channel cuts into main bar	No active secondary low flow channel visible			None	None			-
24/04/2007 15-51 BST

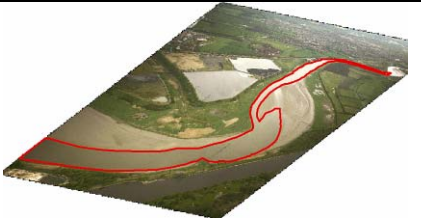
n/a	n/a	0.4	Dominant channel located towards then north bank and meanders across the estuary to the south bank. Lobate flood intrusion channel cuts into main bar	No active secondary low flow channel visible			None	None			-
21/05/2007 13-38 BST

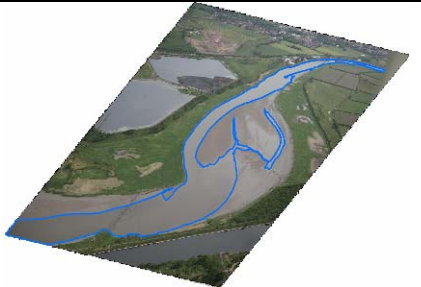
n/a	n/a	0.5	Dominant channel located towards then north bank and meanders across the estuary to the south bank. Lobate flood intrusion channel cuts into main bar	No active secondary low flow channel visible			None	None			-

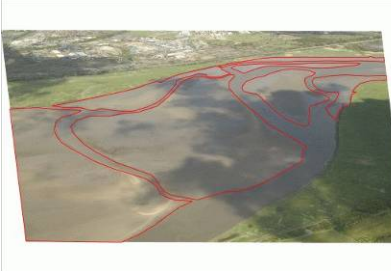
4.53	242.6	1.47	Leaves Hempstones point, meanders part way across estuary, then turns south to abut southern bank where a delta forms. Then runs parallel to south bank out of image.	Ebb flow is split between main channel and secondary channel at northern bank. Relict ebb channel visible towards east (left of image) with a delta at its outlet	-	-	-	-	-	-	-

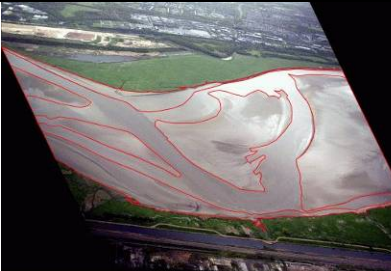
06/05/2005 09.01 BST	w060505i

6.84	296.3	3.29	Main channel has captured secondary channel at north bank.	Loss of secondary channel carrying ebb flow.	-	Secondary channel captured by main channel	-		-	-	39.46 30/04/2005 41.31 01/05/2005 37.98 02/05/2005 46.33 03/05/2005 34.53 04/05/2005
12/05/2005 12.38 BST	w120505i

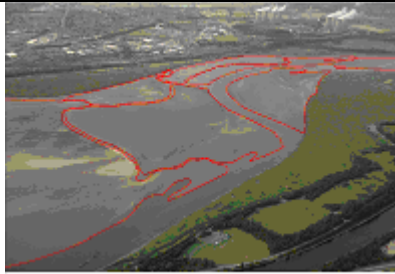
3.88	296.3	1.81	Extends towards the centre of the estuary immediately downstream of Hempstones Point.	dominant channel.	Increase	the north bank and has become the dominant channel.		dominance switched to a former secondary channel located at the north bank which subsequently migrated towards the north bank.	Decay/siltation of formerly dominant channel	Spring 23/07/05 Neap 30/07/05 Spring 07/08/05 Neap 05/08/05	32.86 28/07/2005 37.13 13/08/2005

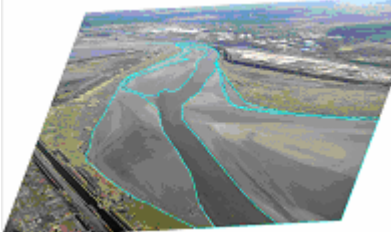
20/02/2006 13.18 BST	w200205i

5.76	30	0.90	Dominant channel located towards the centre of the estuary and extends towards the north bank then meanders towards the south bank	Secondary low flow channel located at the south bank.		Similar broad morphological pattern to 23/01/2005.	Downstream migration of dominant channel.	None	None	Neap 24/01/06 Spring 31/01/06 Neap 07/02/06 Spring 15/02/06	32.50 24/01/2006 58.32 14/02/2006 97.49 15/02/2006 56.29 16/02/2006 57.28 17/02/2006 41.92 18/02/2006 34.54 19/02/2006 31.03 20/02/2006

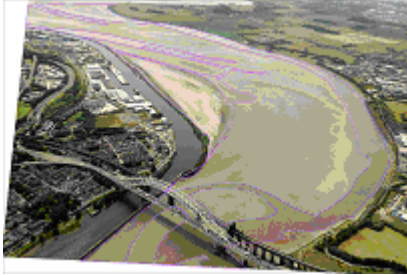
3.35	313.5	0.85	Dominant channel meanders from south bank towards north bank immediately downstream of the SJB, bifurcation has decayed.	As 15/07/05	-	Bifurcation no longer present, although broad morphological pattern is constant.	Downstream migration of dominant low flow channel.	None	Decay of a channel bifurcation; breach in mid-channel barrier island remains. Cuspate bar formed d/s of SJB	Neap 17/06/05 Spring 24/06/05 Neap 30/06/05 Spring 08/07/05	35.46 19/06/2005

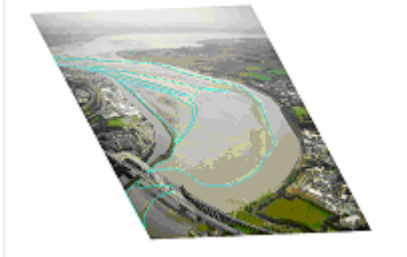
03/10/2005 10.23 BST	sjb031005i

1.36	271	2.8	As 19/09/05	As 19/09/05	-	Dominant low flow channel beneath the Railway Bridges and SJB remains poorly defined, however bar remains present, although narrowed.	None	None	Further narrowing of bar beneath Railway Bridge and SJB.	Spring 20/09/05 Neap 27/09/05	41.61 28/09/2005 51.94 29/09/2005 86.28 30/09/2005 74.59 01/10/2005 33.54 02/10/2005

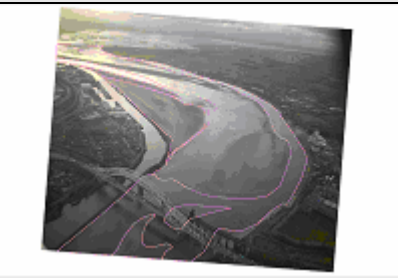
5.49	327.2	1.09	Dominant channel now cuts obliquely across the main bar downstream of SJB	Shallow secondary channel across main bar	Increasing	As 03/10/05, however topographical high of flood levee is less well defined and the dominant low flow channel overflows towards the centre of the estuary.	Downstream migration of part of the dominant low flow channel immediately before it abuts the north bank.	None	Movement of mid-channel bar beneath Railway Bridge/ SJB towards the north bank.	Spring 05/10/05 Neap 12/10/05 Spring 19/10/05 Neap 27/10/05 Spring 04/11/05 Neap 11/11/05 Spring 18/11/05 Neap 25/11/05	42.06 12/10/2005 39.85 13/10/2005 38.07 19/10/2005 43.71 21/10/2005 35.08 22/10/2005 45.81 23/10/2005 126.4 24/10/2005 122.5 25/10/2005 105.5 26/10/2005 73.83 27/10/2005 58.10 28/10/2005 46.08 29/10/2005 46.99 30/10/2005 35.91 31/10/2005 53.01 01/11/2005 79.53 02/11/2005 82.15 03/11/2005 112.1 04/11/2005 82.90 05/11/2005 105.3 06/11/2005 77.47 07/11/2005 116.4 08/11/2005 106.7 09/11/2005 90.87 10/11/2005 98.23 11/11/2005 80.66 12/11/2005 59.21 13/11/2005 58.20 14/11/2005 58.20 15/11/2005 47.52 16/11/2005 37.83 17/11/2005 32.91 18/11/2005 33.78 19/11/2005 31.14 24/11/2005

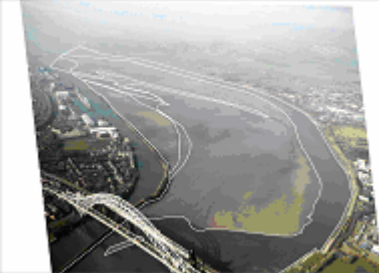
14/03/2006 09.24 BST	sjb140306i

3.85	170.9	1.16	Dominant channel now cuts obliquely across the main bar downstream of SJB	Secondary low flow channel present at a breach of the flood levee.	-	Broad morphological pattern similar, however secondary low flow channel present following a breach in the mid-channel barrier island.	None	None	Movement of mid-channel bar beneath Railway Bridge/ SJB towards the south bank.	Spring 02/03/06 Neap 08/03/06	34.38 01/03/2006 30.43 02/03/2006 59.44 07/03/2006 105.8 08/03/2006 101.1 09/03/2006 116.6 10/03/2006 78.66 11/03/2006 56.47 12/03/2006 58.73 13/03/2006 75.74 14/03/2006
14/04/2006 10.47 BST	sjb140406i
